Inspection Report

123 Anywhere
356yy Mo.

Complete Stucco Inspections

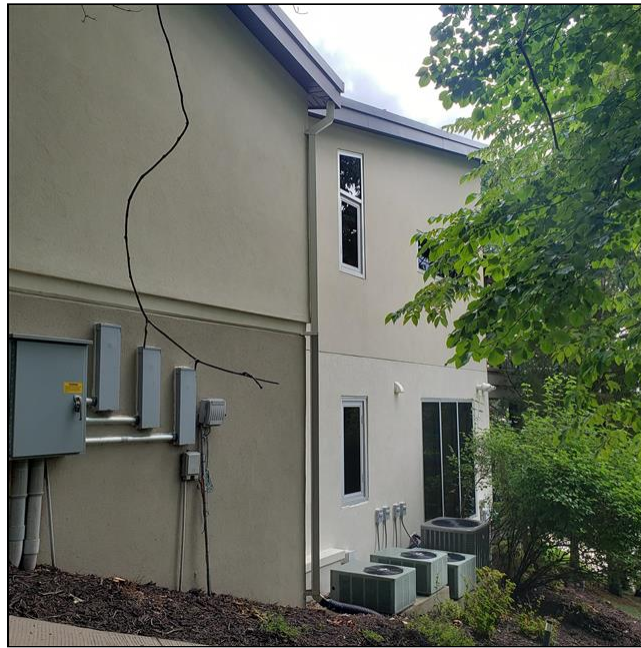
all landscaping slopes away from the foundation

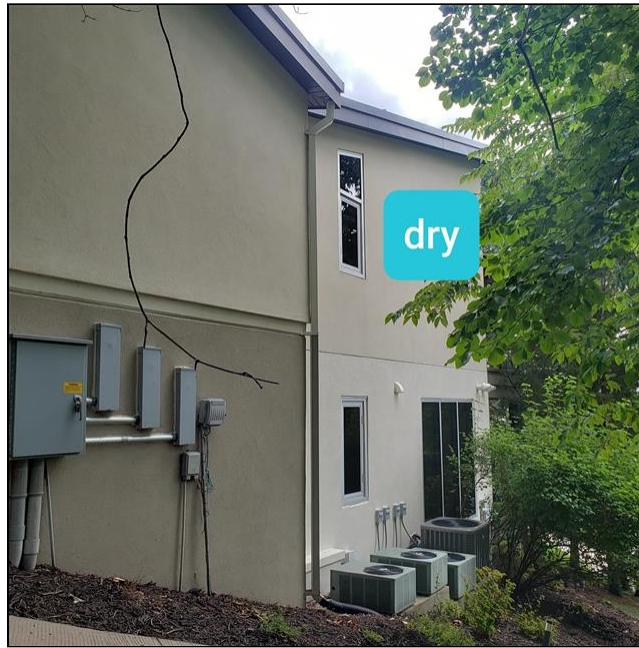
gutter downspouts

all guttering and downspouts appear to be functioning correctly

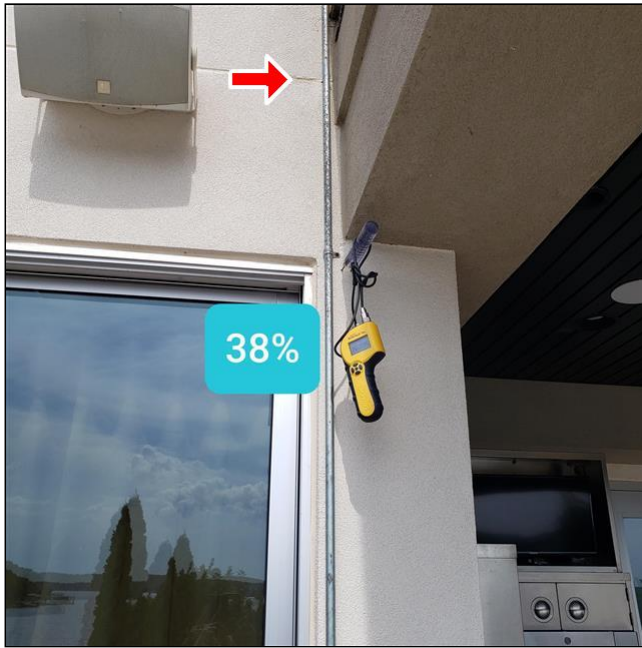
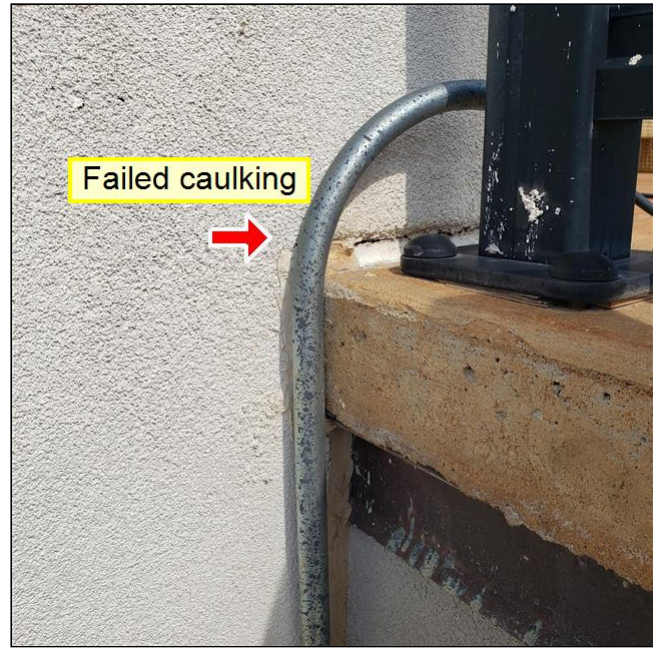
I believe this reading is caused by the upper deck caulking and an area where the caulking has failed where this arrow points

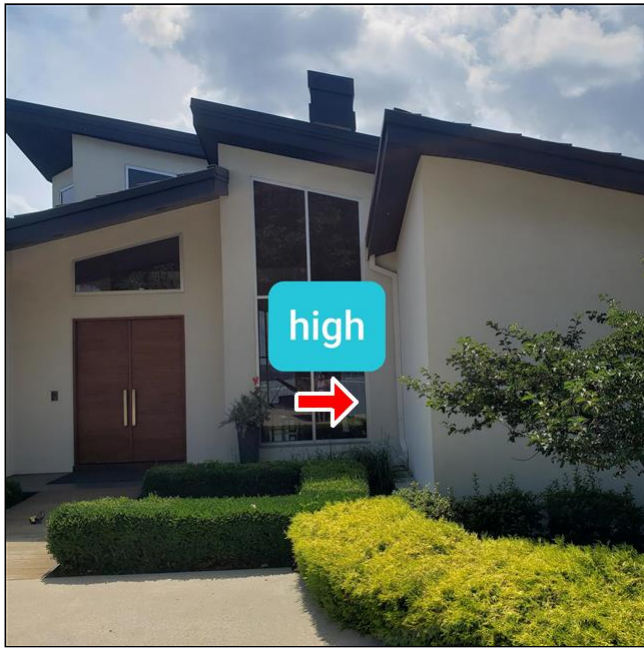
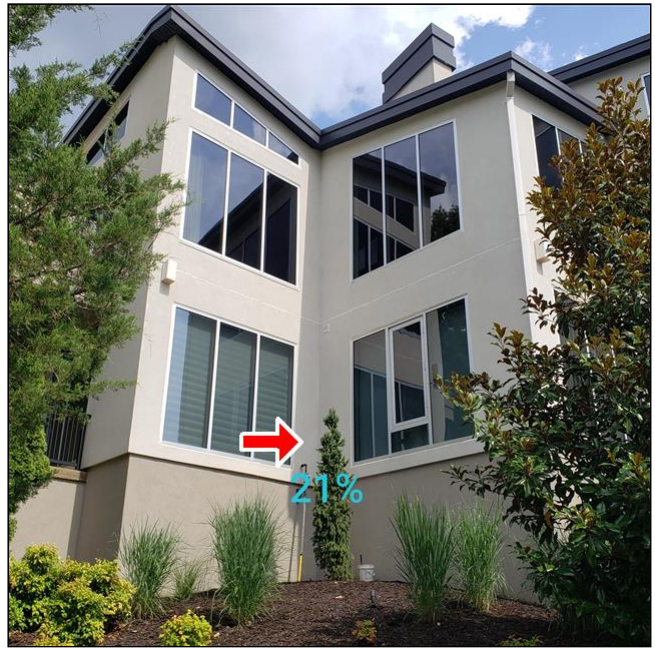
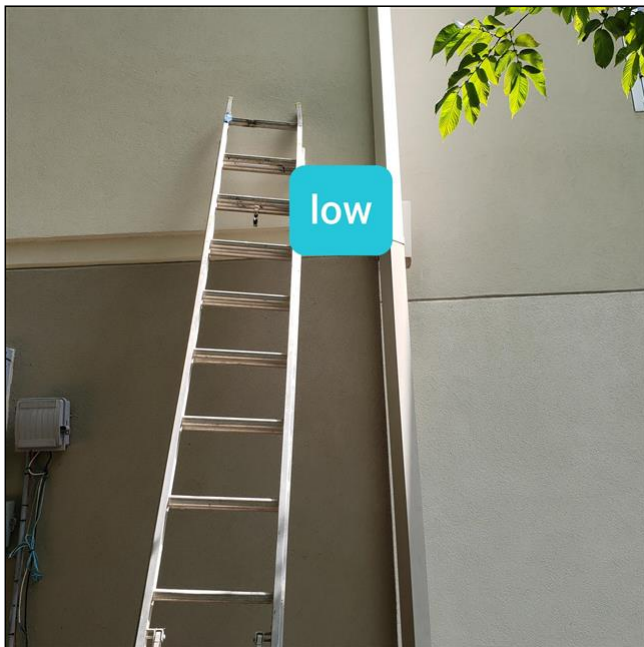
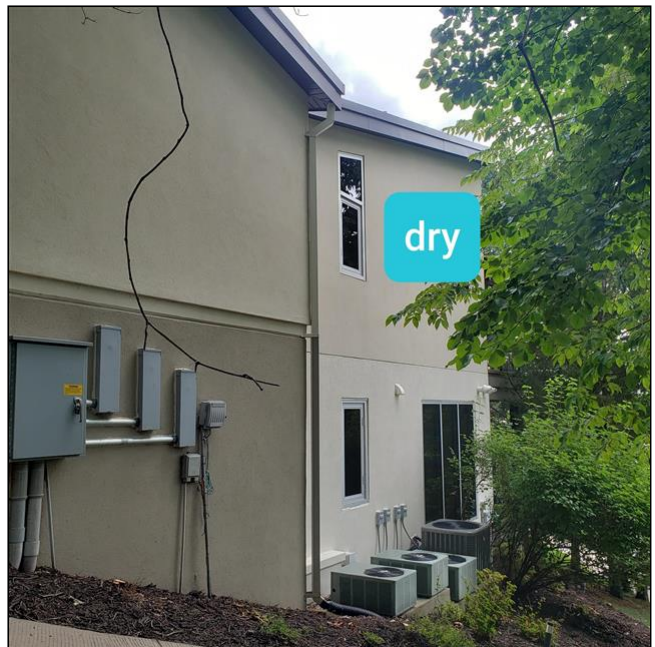
There was a high reading in this corner, I recommend a qualified stucco contractor remove a small test area to inspect plywood and framing , then re-surfaced this area
