Inspection Report

123 Anywhere
356yy Mo.

Complete Stucco Inspections

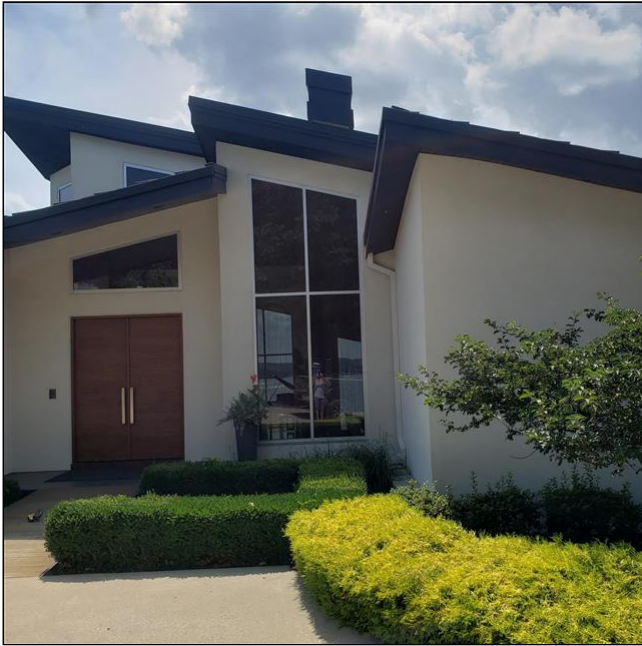
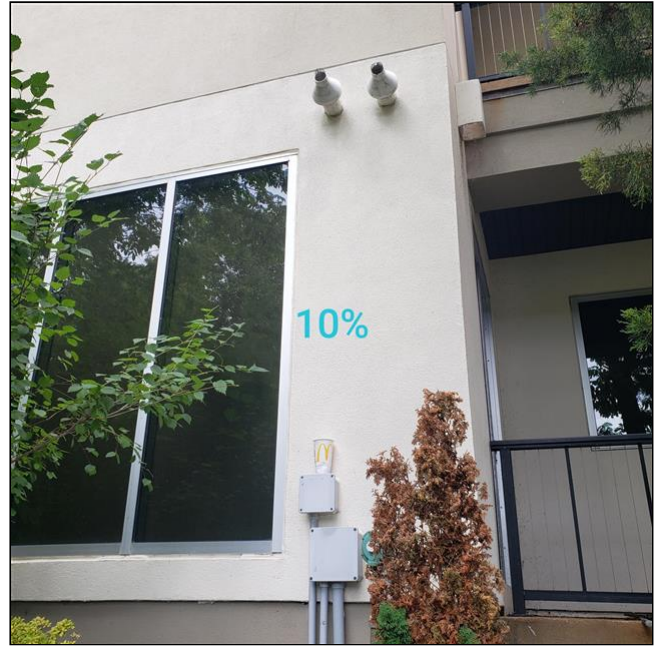
EIFS is an abbreviation for, Exterior insulation and finishing system, it consists of a house wrap over the sub straight followed by a foam board or cement board, then a fiberglass reinforcing mesh, then a 1/8 inch base coat, followed by a finish coat
